MONITORING OF TRACK SECTIONS WITH LONG-PITCH CORRUGATION

ABSTRACT. The focus of this paper lies on monitoring of the track sections with rail corrugations caused by wheel sliding. Short waves on the running surface of the rail head on low rail are typical for this defect. Long-pitch corrugation is a significant cause of vibration and noise pollution in the railway infrastructure. Therefore it is very important to understand the formation and development of this imperfection of the rails. Measurements were carried out in curves of small radii on several tracks in the Czech Republic. In addition to the measurement of the surface of the rail head a number of supplementary parameters was evaluated for each section, such as curve radius, superelevation, track gauge etc. and the speed of passing trains as well. This paper describes rail corrugation defect and its development. Our early results are presented in the Conclusions.

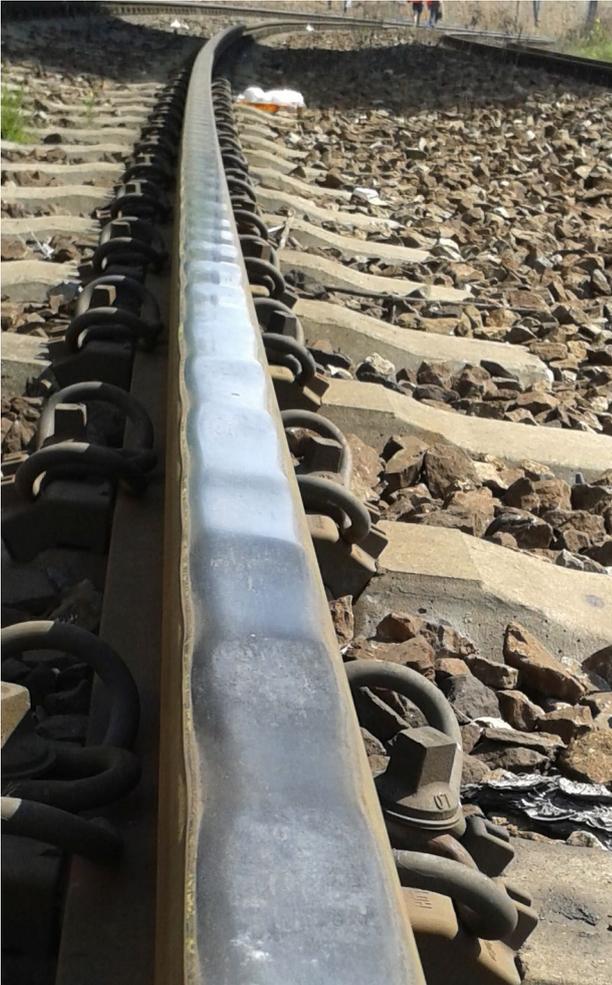
FIGURE 1. Long-pitch corrugation in Havlíčkův Brod

The long-pitch corrugation, sometimes called also as "short waves", is a sinuous inequality of the running surface of the rail. Distance between wave peaks is usually between 8 and 30 cm and the depth ranges between 0.1 and 1.2 mm. A typical location, where long-pitch corrugation could be found, is the lower rail in curves of radius less than 600 m, sometimes even 700 m [2, 3]. The cause of these corrugations is the difference in length that each wheel of the wheel-set rolls along the curve on the low and high rail. This difference also causes the wheel slip, occurring mostly on the low rail. Slip happens not only in the longitudinal direction, but also in the lateral direction. In most cases, long-pitch corrugation does not occur alone. Such defects, which are accompanying the long-pitch corrugation, can be sorted to:

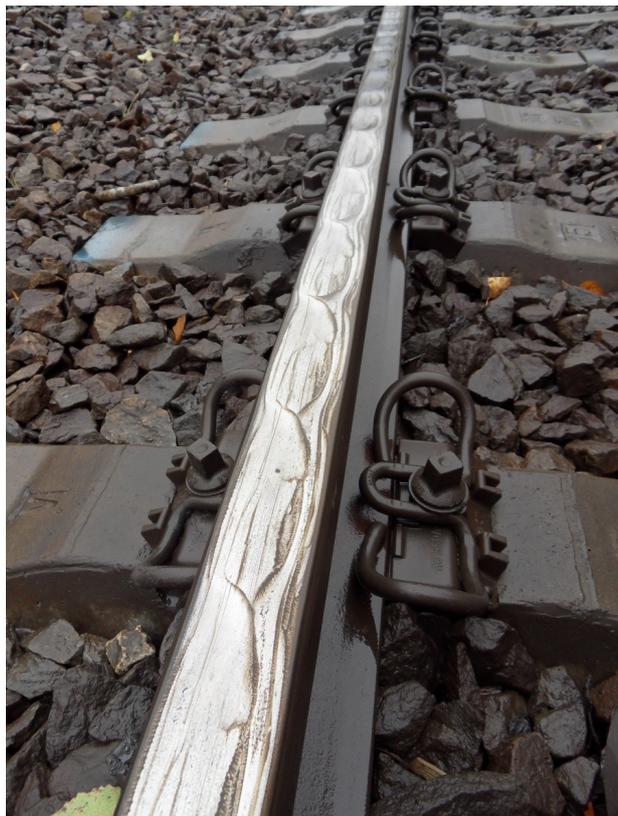
FIGURE 2. Highlighted long-pitch corrugation by contaminant in Havlíčkův Brod

As you can see on Figure 2, the long-pitch corrugation forms very interesting shapes which are changing fluently throughout the curve.

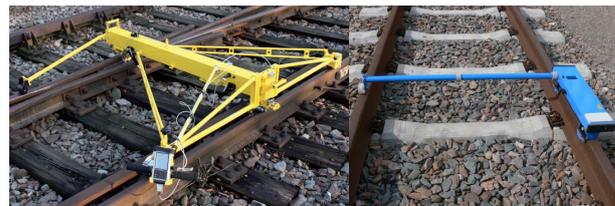
FIGURE 3. Trolley Krab (track geometry) [5] and Salamander (corrugations)

- visual inspection and photo documentation,
- measurement of track geometry by the trolley Krab,
- measurement of wavy deformations of the rail head by the device Salamander,

The track geometry is measured to describe the current state of the track, which unfortunately in many cases does not correspond to the data found in the railway documentation. Another reason for these measurements is the need for additional information such as track gauge, gauge widening etc. The microgeometry of the rail head, specifically wavy deformations, was measured using the device Salamander. Unfortunately, in some cases it was not technically possible to measure a curve as a whole, which is the reason, why only few selected sections were measured within these locations. Measured data are evaluated by the device in accordance with EN 13231-3 [4] in wave lengths:

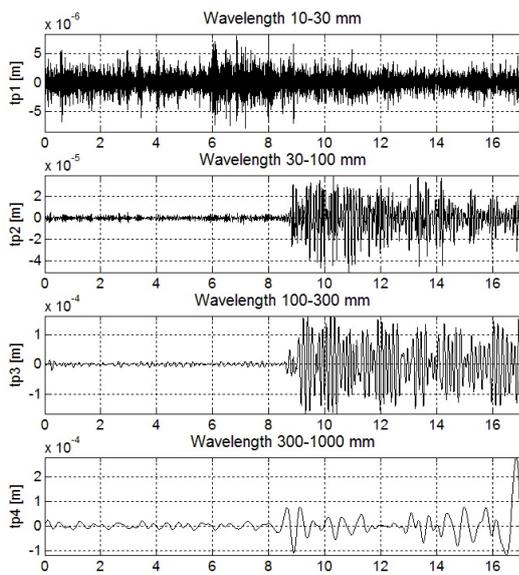
Measurement: MDK₁51120144037, Line: Vyskov, Start Km: 1, Rail: 1

FIGURE 4. The processed record from the device Salamander shows a track, where in one part the rails were replaced and in the other part the rails with long-pitch corrugation were left.

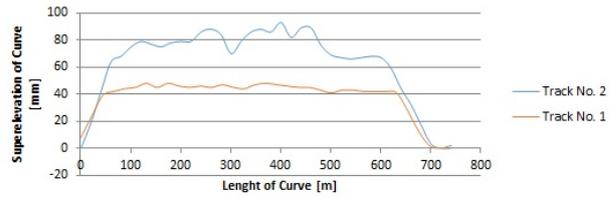
FIGURE 5. Cant in track No. 1 and in track No. 2 in curve A.

One of the monitored track locations is a part of the track No. 324 Havlíčkův Brod – Kutná Hora in between the km 224.394 and km 225.150 in approach to the station Havlickuv Brod from the direction Kutna Hora. The location consists of a double track with consecuting reverse compound curves. First curve is for the purposes of this work named A and is closer to the station. The second curve is named B and is located further from the station in direction Kutná Hora. The cant of the track was measured, using the device Krab, which showed a different value of the cant for each track. The results of the train speed measurements were the differing speeds of trains in both tracks and both curves. After the calculation of the weighted averages, the data revealed the presence of cant excess in both tracks and both curves.

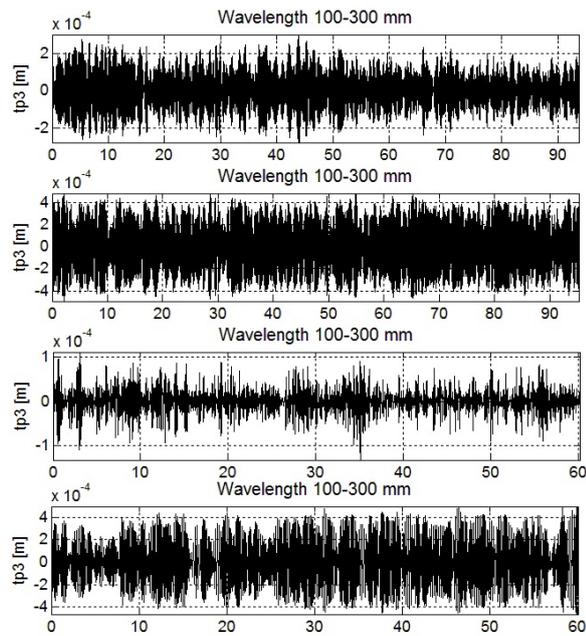
FIGURE 6. Category of wavelengths 100 Å 300 mm Havlickuv Brod (from the top: curve A of the first track, curve A of the second track, curve B of the first track and curve B of the second track).

The train speed in the curve A in the track No. 1 is affected by braking/accelerating near Havlíčkův Brod station. Some freight trains heading from Kutná Hora stopped at the station head in such a way that the end of the train was standing in the curve ($E = 2$ mm). Unfortunately, this situation is a common practice in Havlickuv Brod. It facilitates the document handover by the stopping of the locomotive just in front of the station building. The data proved that both rails are nearly under the same load, since the weighted average E/I was close to zero. The record of the wavy deformations for wave lengths $100 \div 300$ mm is shown on Figure 6 on the first line. For the curve A on track No. 2 the weighted average equals $E = 27$ mm. When comparing with the track No. 1 the wavy deformations reach the amplitudes twice as high (Figure 6, second line).

On the contrary the cant excess markedly dominates in the curve B in comparison to the curve A. The weighted average the curve B equals $E = 57$ mm. The state of microgeometry as shown on Figure 6 (fourth line) is practically identical to the curve A of this track. The track No. 1 of the curve B is passed with almost all trains with an cant excess ($E = 72$ mm) since they have to reduce the speed according to a change of allowed speed between the curves. In the past, the railway infrastructure administrator tried to improve the situation by reducing the allowable

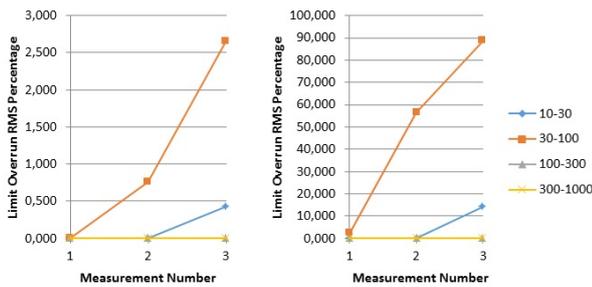
FIGURE 7. comparison of RMS values [%] (to the left the measuring point in front of the tunnel A and to the right the measuring point in front of the tunnel B in location Hady).

Figure 7 shows the comparison of development speeds of wavy deformations (here represented as a percentage of the boundary overrun of the RMS limit value, RMS = Root Mean Square) in both curves in location Hady. Initial analyses of the data show significant differences in development of the long-pitch corrugation in the curves with small radii. Considering the common structure and geometrical parameters of the track (curve radii 283 m and 261 m, cant 123 mm in both curves, fastening W14, sleepers B 91S etc.) and the railway superstructure they do not exhibit significant differences. The curve B (in front of the tunnel B) embodies the weighted cant deficiency $I = 67$ mm. The curve A (in front of the

tunnel A) shows the weighted cant deficiency $I = 47$ mm. Unfortunately, these values have to be considered as tentative, since the train speeds were affected by the day time in which the measuring took place. The majority of the recorded trains were passenger trains; the freight trains pass this location mostly at nights due to very strong suburban traffic. Also it has to be pointed out, that the track configuration is similar to that in the location Havlíčkův Brod (namely the curve A of the track No. 1). There is a turnout located just behind the measuring location and freight trains approach the station through the side direction of the turnout at 60 kph at maximum. Passenger trains pass the turnout in straight direction at speeds up to 70 kph (or up to 75 kph for trains using the cant deficiency 130 mm). When we take into consideration that the measured train speeds were just tentative, the calculation offers results, in which the values for cant deficiency are logically lower (for the section in front of the first tunnel). This partial conclusion shall be confirmed or refused as soon as possible.
