RECONSTRUCTION OF THE HISTORICAL BUILDING FOKSAL 13 AND 15 IN WARSAW

ABSTRACT. We were asked to design geotechnical structures to enable reconstruction of historical buildings. Buildings have to meet current standards so load bearing capacity had to be increased and underground garages can be built. A description of the securing construction pit is described below as well as the design of the deep foundation. The construction pit was secured by jet-grouting columns with struts and soil nails. Parts of the walls were underpinned by micropile trestles. Jet-grouting columns were also used for the deep foundation of existing walls.

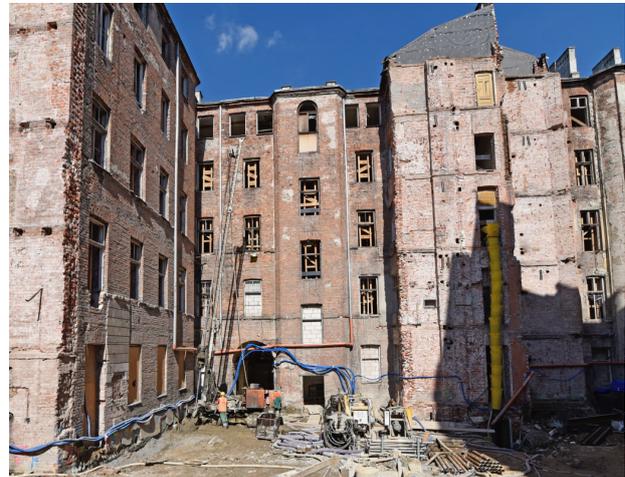
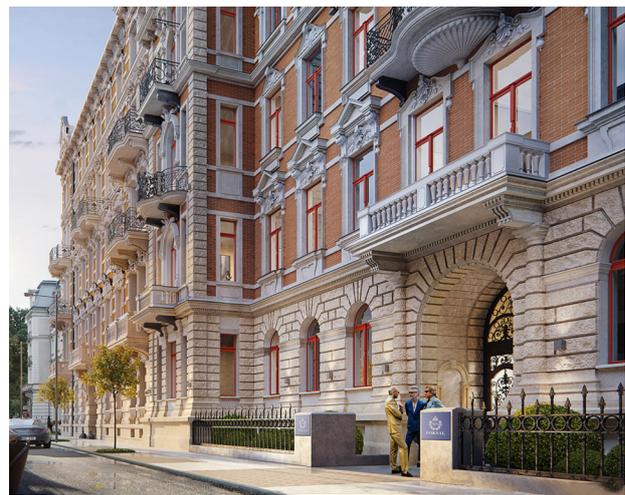
FIGURE 1. Historical building Foksal 13 before (top) and after (bottom) reconstruction.

The block of flats on Foksal Street was built in the late 19th century and, as one of the few buildings in Warsaw, it survived the Second World War. After the war it was initially used as rented housing, but nobody invested in their maintenance because it was intended that they be demolished due to the construction of a tram line. In the 1990s residents were evicted because of the threat to health and life. A major rebuilding began in 2016. The development of the whole project was characterized by the investor's effort to find the easiest solution, while on the other hand the requirements of heritage conservation institutions was to protect historically valuable buildings in the centre of Warsaw. The investor wanted to build for luxury living and a necessary condition for this standard was the obligation to add underground garages to the floor plans of both buildings. The compromise solution eventually became an approved version involving the demolition of the rear and middle wings of Foksal 15. In place of the demolished wings, underground garages were built, while new wings of the same extent and the same facade construction were also built. The state of the building before and after reconstruction is shown in Figure 1.

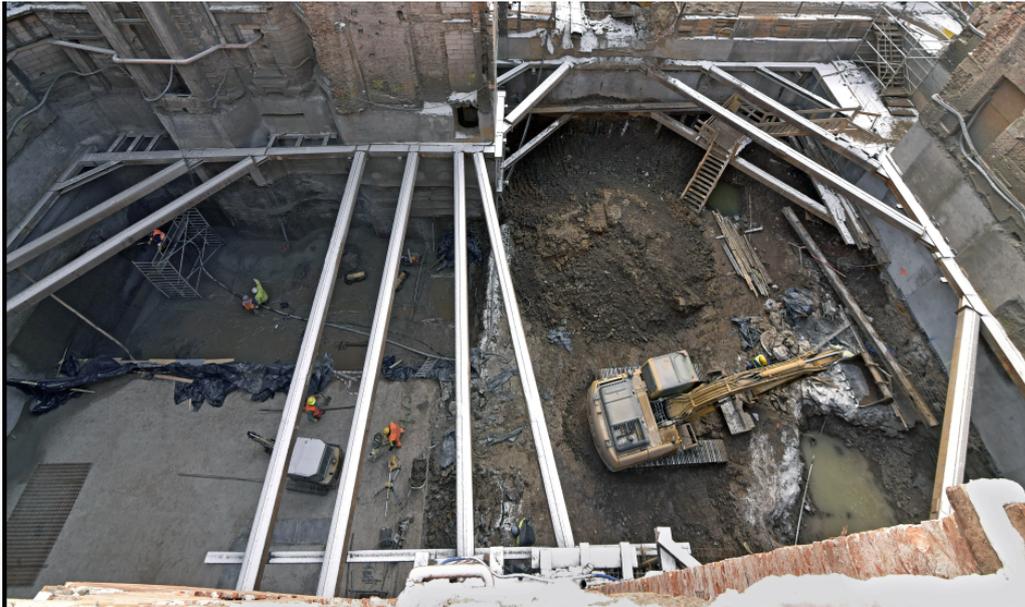
FIGURE 2. Construction pit – blinding concrete in process.

In the area of a 30 m long microrider bracing, the steel frame emplaced at three levels, since no anchor elements could be used beyond the investor's own land. The pit is captured in Figure 2 while its technical scheme including all the designed solutions is shown in Figure 3.

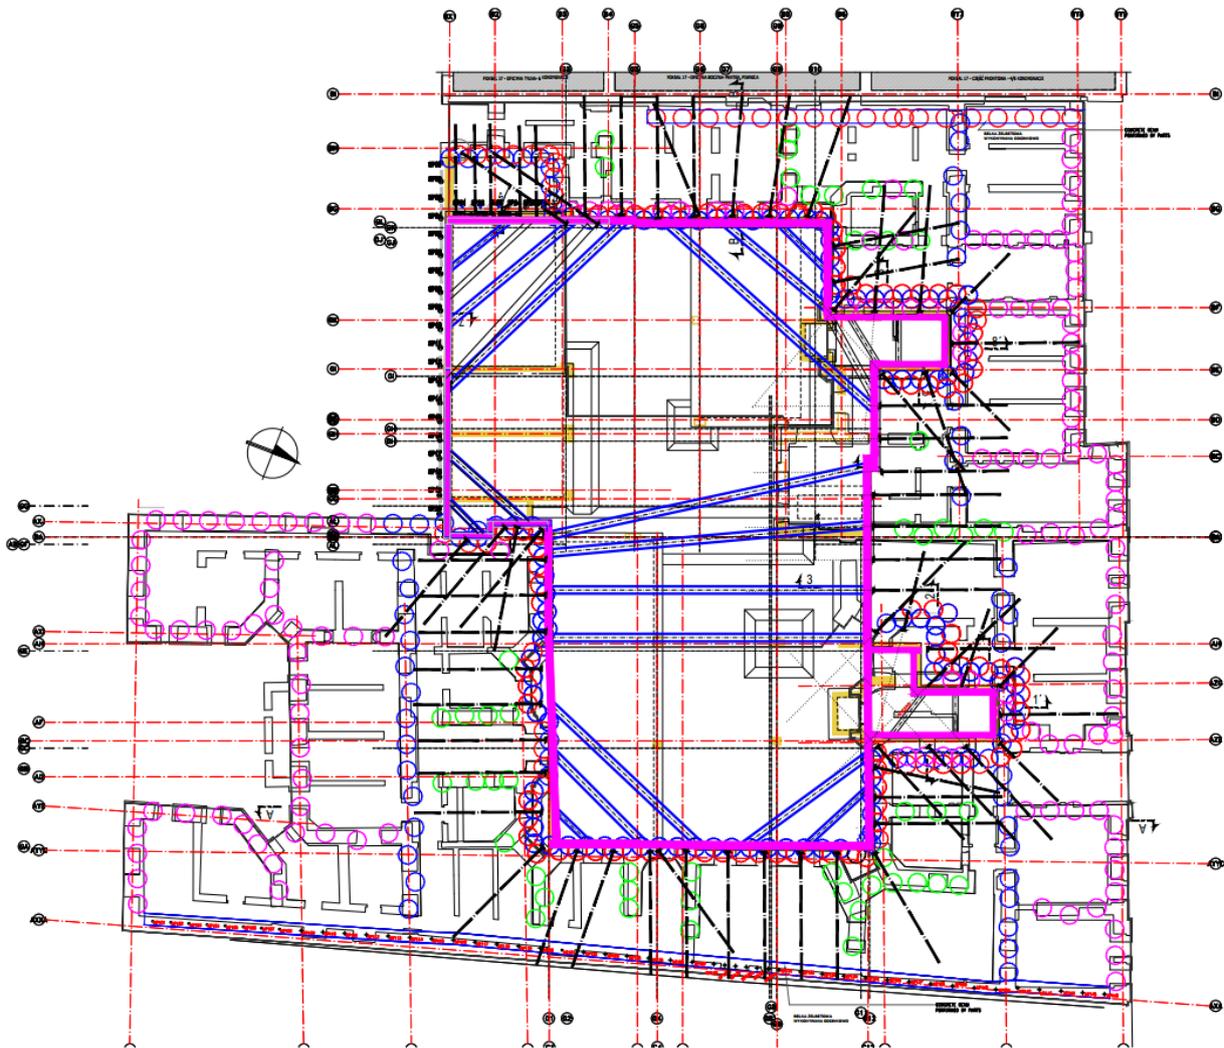
FIGURE 3. Layout – all the designed construction in one drawing.

Maximum excavation for newly built garages is 8.7–11 m below the existing terrain. The perimeter of the building pit is 140 m, of which 110 m is secured by two rows of jet grouting \varnothing 1000 mm with reinforcement pipes \varnothing 108/12. The remaining 30 m of the construction pit is secured by a microrider bracing made of profiles HEB 160.

All shoring walls were shotcreted with concrete of thickness 10–25 cm, secured with nail length of 4.5–7.5 m at 2–4 levels. Shotcrete was performed from the maximum excavation level to 1 m below existing terrain. At a level of –3.2 m the pit is secured by a steel frame consisting of struts and horizontal beams. Struts had lengths up to 19 m. Horizontal beams along the whole construction pit was made of steel profiles 2×IPE 330 to 2×IPE 400. It created a solid and stiff element that prevented the movement of the perimeter walls towards the building pit. Struts were designed from HEB 200 and HEB 300 profiles. The longest struts were designed from a pair of sheetpiles L604. Some of the struts passed through the micropile foundation.

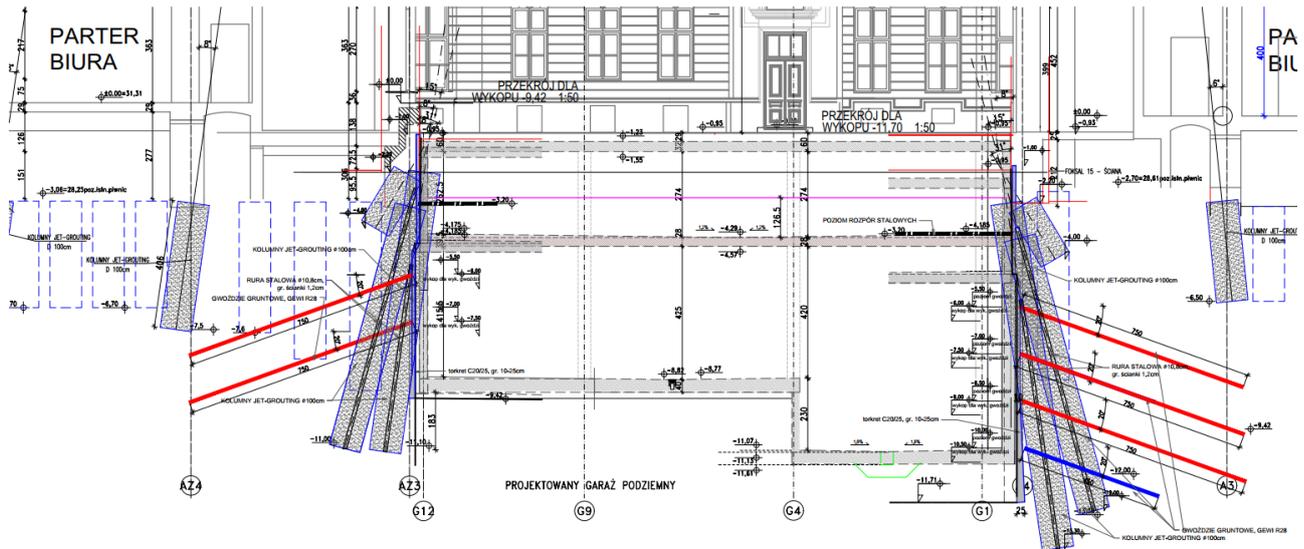
FIGURE 4. Cross section of the underground part of the building.

The columns of jet grouting were made from the ground floor (see Figure 4), which was partly under the protection of a heritage conservation institution. In the original design of demolition, all non-load-bearing walls on the ground floor were to be demolished. Based on this assumption, the starting points for drilling jet grouting were determined. However, after a renegotiation between the investor and the heritage conservation institution, changes were made and part of the non-bearing walls had to be preserved. In addition, there was a strict ban on doing any damage to the existing stairways, which were lined with marble. This resulted in a major redesign of starting points for the jet grouting columns.

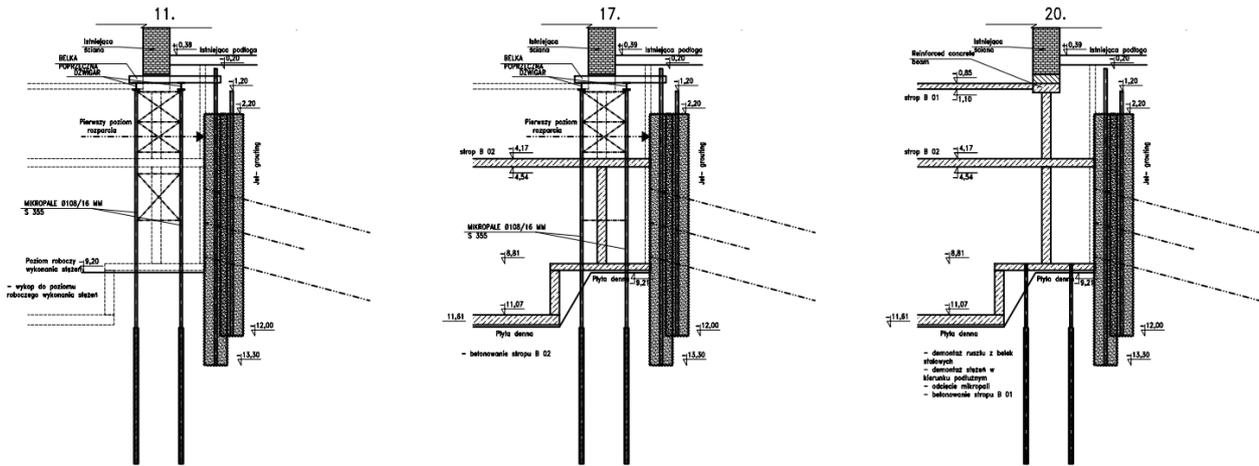
FIGURE 5. Cross section of micropile underpinning – selected phases.

In the first stage, the micropiles were made from the existing yard terrain on one side of the cast wall and from the side of the basement of the building. Complications were brought by drilling of micropiles just from the basement, where the spatial conditions were very tight. Due to the low height of the ceiling micropiles had to consist of pieces with lengths of 1.0 and 2.0 m. All micropiles were inserted into boreholes \varnothing 160 mm, filled with cement grouting. Underneath the level of the future definitive excavation of the garages, injected micropile roots in lengths of 6.0–8.0 m according to load were made.

In the second phase, the micropiles were fitted with steel heads and the distribution grid was proceeded with. The distribution grid was designed above the future ceiling of the 1st underground floor of the new building. The reason for this was the simple connection of the ceiling to the supporting wall. First, holes were made in the masonry to accommodate the steel cross members. Then the whole steel grid was thoroughly welded. In the end, the wall perforations were filled with concrete, thereby bringing into contact the steel grid and the masonry.

The third phase consisted of micropiles bracing in both directions. Individual phases are indicated in Figure 5.

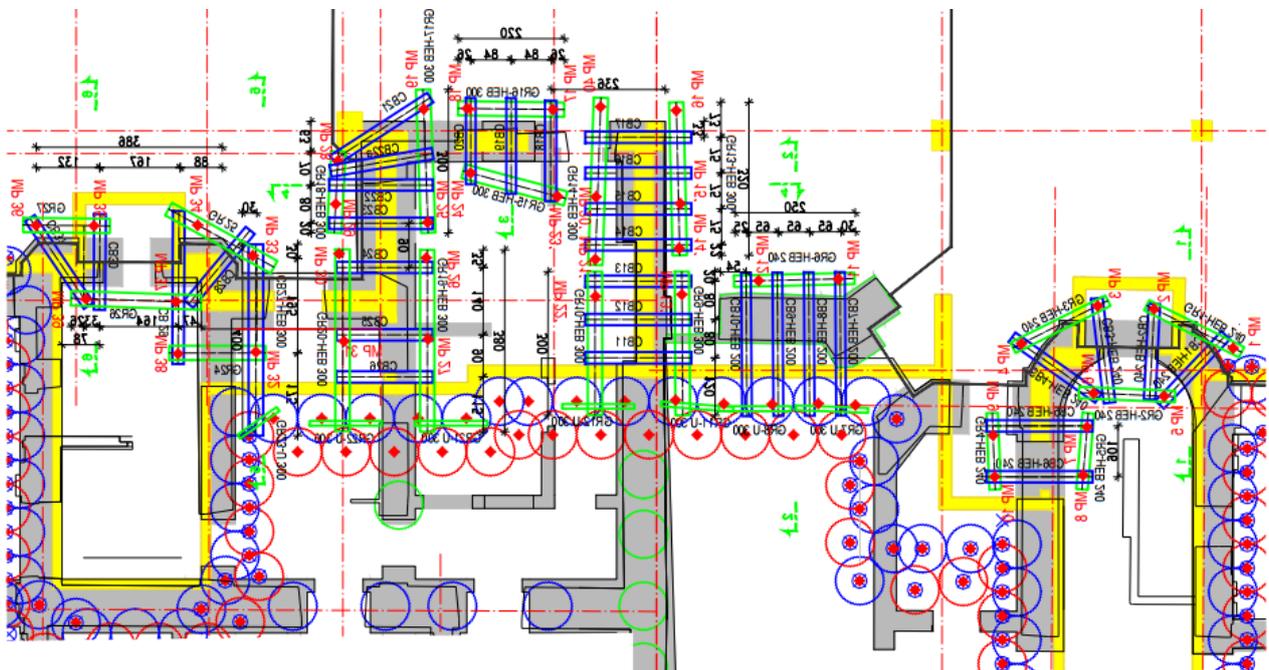
FIGURE 6. Layout of micropile underpinning.

After the foundation slab was concreted, the process of building walls and removing bracing was begun. In total, 40 micropiles with a total length of 760 m were made. The layout of micropile underpinning is shown

in Figure 6.
