RESPONSE AND DAMAGE EVOLUTION OF SINGLE EDGE NOTCHED TIMBER BEAMS UNDER THREE-POINT BENDING

ABSTRACT. Two groups of small-size single edge notched beams (SENB) made of European spruce (*Picea abies*) were tested in three-point bending (3PB) until failure under displacement control. The first group comprised of eight solid and two glued laminated (GL) timber beams manufactured with (a) the single edge notch at the bottom of the mid-span and (b) the reduced ligament depth. The second group consisted of four GL timber beams with the single edge notch only. We employed digital image correlation (DIC) to quantify strains and displacements, capture the damage evolution, and track the sequence of failure patterns. In this work, we present response of the beams in terms of load vs. crosshead displacement of the moving crosshead and load vs. crack tip opening displacement (CTOD).

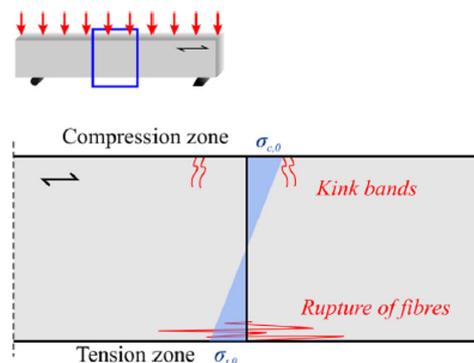
FIGURE 1. Single edge notched beam [1].

RILEM and CIB-W18 ([1]) recommend performing the 3PB test of SENB (Figure 1) to obtain a stable crack extension in the direction parallel with the grain from an initial notch to the complete separation of the crack faces. Representing the fracture mode I, i.e. cracking under tension stress perpendicular to the crack plane, the test is used for calculation of fracture energy. Many studies involving the SENB bending test have been conducted ([2], [3], [4], [5], [6], [7]).

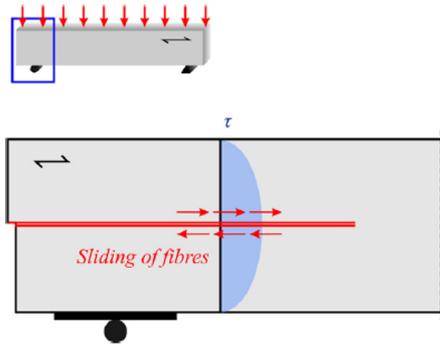
FIGURE 3. Sketch for shear failure [9].

the presence of natural defects. Nevertheless, shear stress can be governing for the design of some timber members, e.g. short beams. Its maximum is reached around the supports causing brittle failure parallel with the grain where the fibers bundles or layers slide (Figure 3). The area of a support or a loading point is typical for compression stress perpendicular to the fibers that leads to a ductile failure (Figure 4).

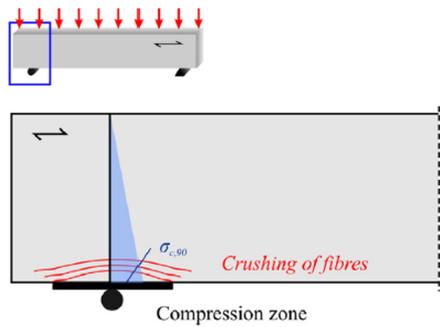
FIGURE 4. Sketch for compression failure [9].

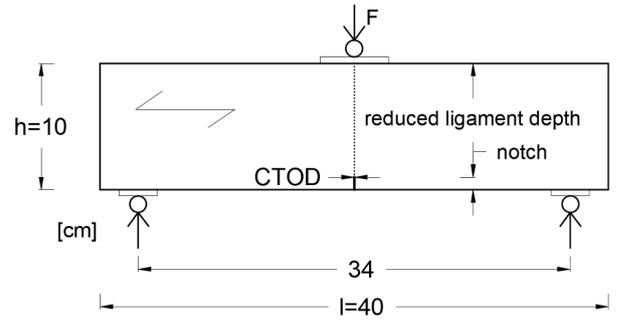
FIGURE 5. Three-point bending test (3PBT) configuration common for all the beams: length of 40 cm, cross-section height of 10 cm and single edge notch length l_n of 1 cm.

We conducted three-point bending test (3PBT) of two groups of beams, both with the length l of 40 cm, cross-section height h of 10 cm and single edge notch with the length l_n of 1 cm (Figure 5) and the width w_n of 0.1 cm. The first group was composed of eight solid and two glued laminated timber beams with cross-section width w of 5 cm and reduced ligament width w_{li} of 2 cm. The second group consisted of four glued laminated timber beams with cross-section width w of 4 cm.

We ran the experiment under displacement control at the rate of 2 mm/min. In this regime, we were able to record the descending branch of the load-displacement curve. Furthermore, digital image correlation (DIC) was applied, with mostly 10 sec time interval, to capture strains, displacements (e.g., crack tip opening displacement CTOD, see Figure 5), damage evolution and failure type sequence.

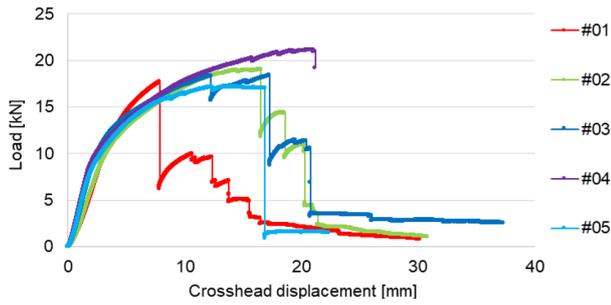
FIGURE 6. Load vs. crosshead displacement of the group one beams with the first failure F1 - splinter around the ligament.

The load-crosshead displacement responses of the group one beams with the single edge notch and reduced ligament depth are plotted in Figure 6 and Figure 7 for the first failures denoted F1 - splinter around or at the ligament and F2 - splinter around or at the ligament accompanied by shear failure, respectively. Furthermore, for the beams with F1, the load-CTOD curves are shown in Figure 8. The following subsections present the damage evolution and failure type sequence of individual beams.

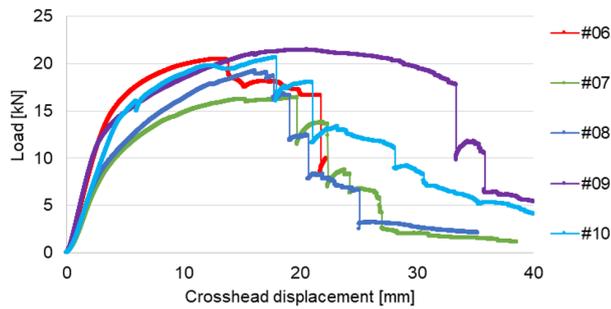
FIGURE 7. Load vs. crosshead displacement of the group one beams with the first failures F2 - splinter around the ligament + shear.

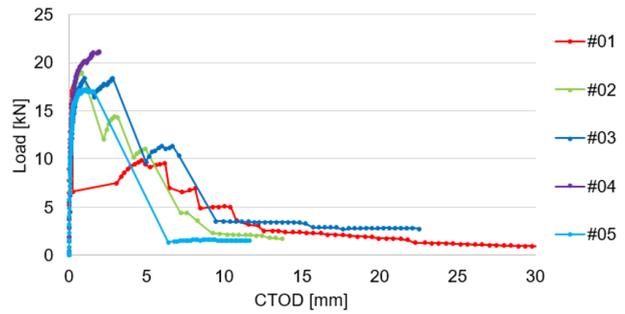
FIGURE 8. Load vs. crack tip opening displacement (CTOD) with the first failure F1.

branch. Furthermore, we obtained the load-crack tip opening displacement (CTOD) for the beams with the reduced ligament depth (group one) where the first failure of splinter occurred.

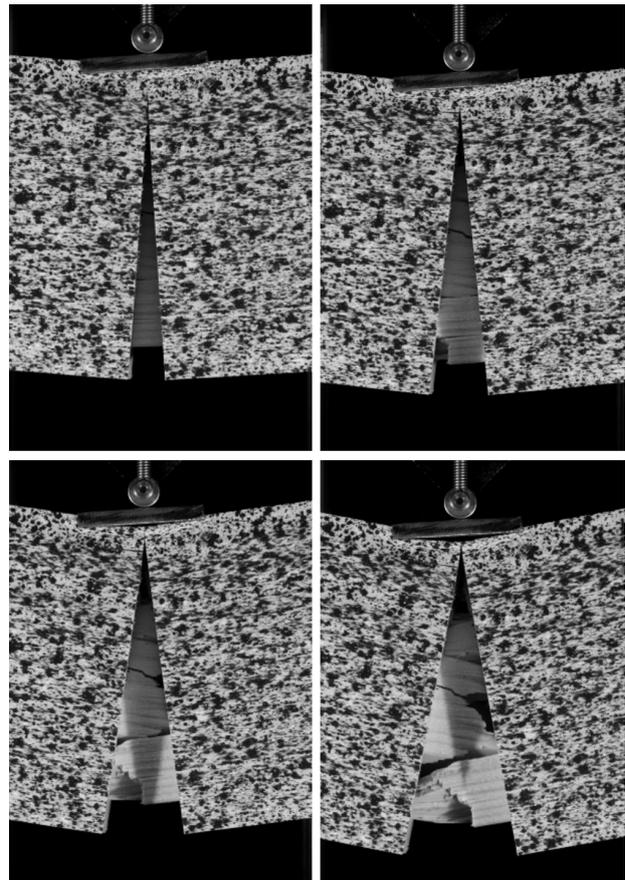
FIGURE 9. Damage evolution of the beam #01 with the first failure F1 - splinter around the ligament.

The beam #01 represents the failure type F1 for the beams #01 - #05. Its damage evolution is shown in Figure 9. Observing the photos of the load stages, we can see failure F1 - splinter at or in the vicinity of the reduced ligament being the only failure type that occurred.

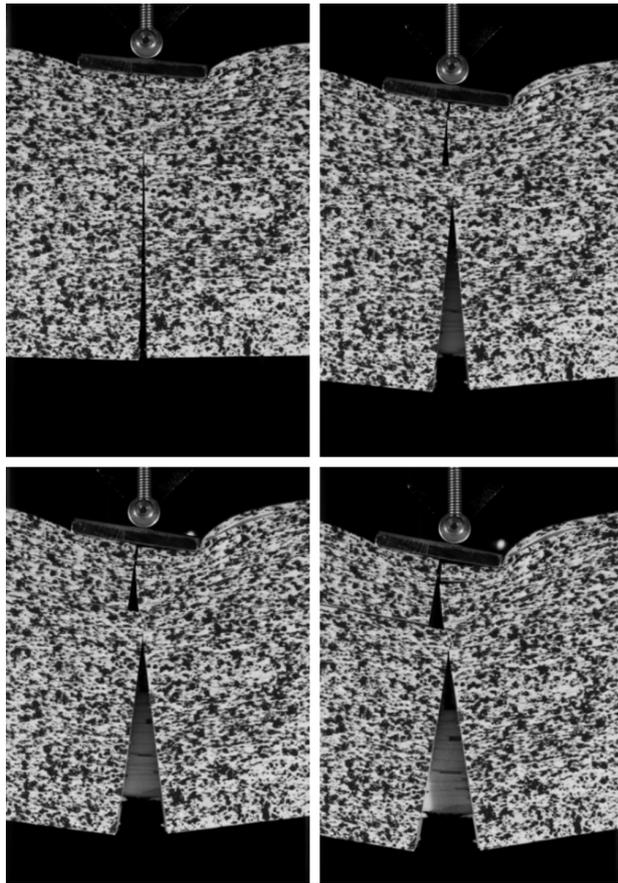
FIGURE 10. Damage evolution of the beam #08 with the failure F2 - splinter around the ligament and shear failure.

The beam #08 represents a specific type of the failure F2 occurring in two beams (#08, #10) out of the group one. The damage evolution is shown in Figure 10. The photos of the load stages show that failure F2 is composed of (a) splinter at or in the vicinity of the reduced ligament and (b) shear failure of a grain bundle reaching at the beam length and occurring both inside and at the cross-section boundaries, namely at the painted front face of the beam, see Figure 11 (left). The latter failure causes leaning of the sheared grains against the other ligament face affecting the overall response, especially CTOD of the notch.

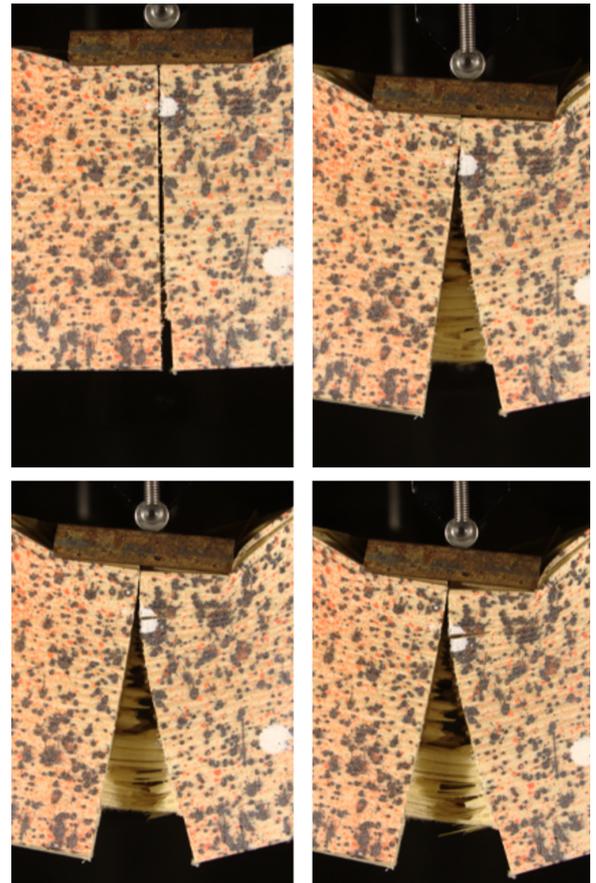
FIGURE 12. Damage evolution of the beam #09 with the failure F2 - splinter around the ligament and shear failure.

The beam #09 represents the failure type F2 occurring in three beams (#06, #07, #09) out of the group one. The damage evolution is shown in Figure 12. Observing the photos of the load stages, we can see that failure F2 covers (a) splinter at or in the vicinity of the reduced ligament and (b) shear failure of a grain bundle inside the cross-section, see Figure 11 (right).

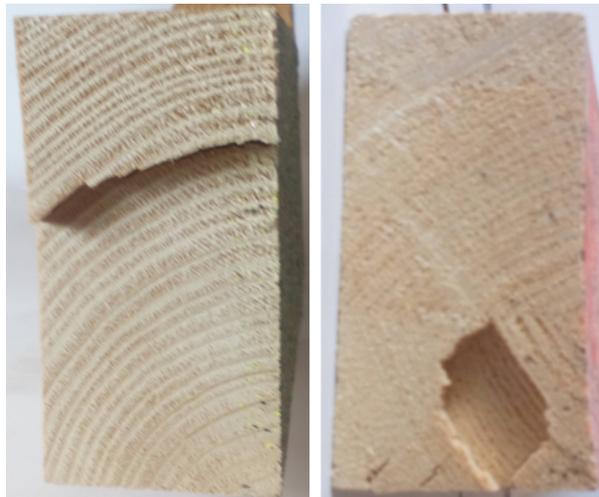
FIGURE 11. The end of the beam #08 (left) and #09 (right) demonstrating the shear failure.

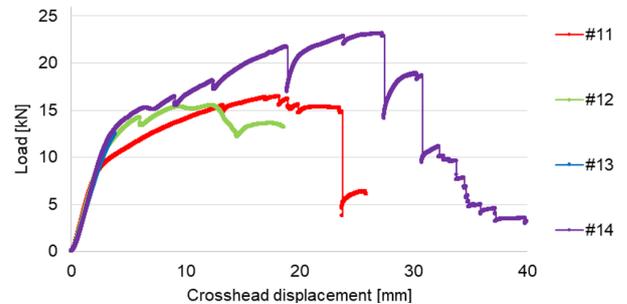
FIGURE 13. Load vs. crosshead displacement of the group two beams with the first failure F3 - parallel with the grain.

The load-crosshead displacement responses of the group two beams with the single edge notch only are plotted in Figure 13 for the failure denoted here F3 - parallel with the grain being initiated at the

notch tip. Let us mention that we do not report on the fifth beam from group two due to the presence of cross grain although the first failure type was also F3 - along the grain. We present the response of the beam #13 only up to the first crack initiation (F3) that was consequently accompanied by unequal vertical displacement along the cross-section width above one of its supports resulting in torsion of the beam. Compared to it, the beam #12 response captures not only the first crack initiation (F3) but also its opening. The following subsections present damage evolution and failure type sequence of individual beams #11

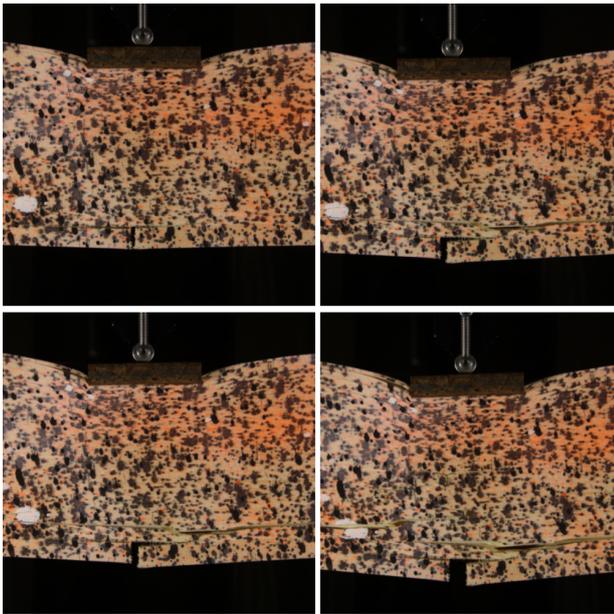
FIGURE 14. Damage evolution of the beam #11 with the failure F3 - parallel with the grain followed by splinter above the notch.

The beam #11 failed in tension. We can see in Figure 14 that (a) the first crack was initiated at the

notch tip and spread along the grain (F3) and then (b) splinter above the notch occurred. The similar crack pattern can be visible on the back face of the beam, see Figure 15.

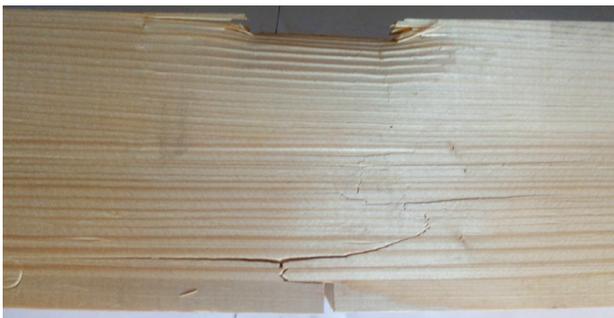
FIGURE 15. Back face of the beam #11.

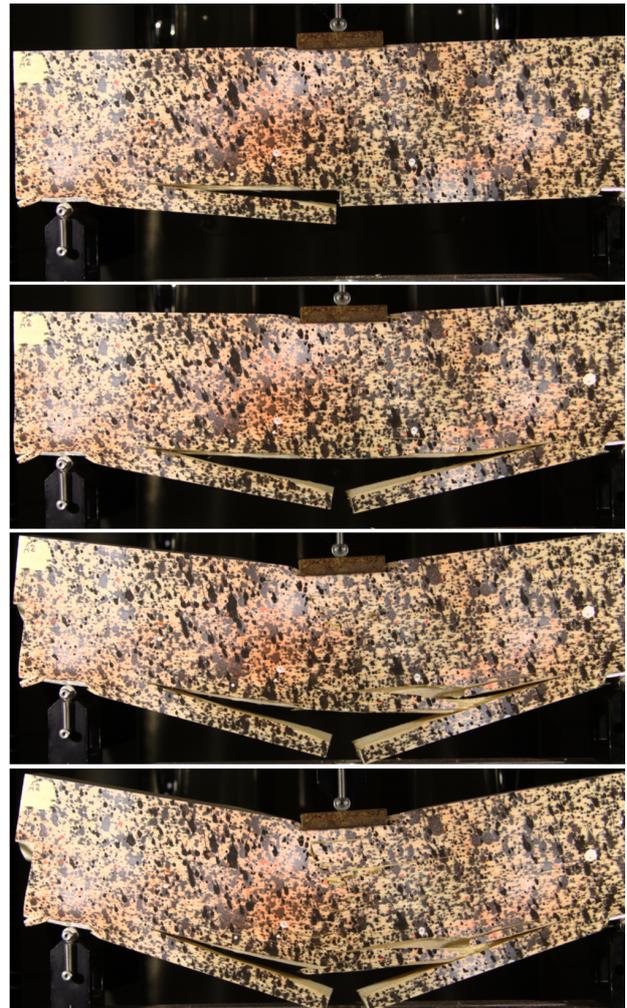
FIGURE 16. Damage evolution of the beam #14 with failure F3 - parallel with the grain followed by splinter above the notch and shear failure.

The failure pattern of the beam #14 is the same as that of the beam #11 except that the splinter above the notch is accompanied by shear failure of a timber layer in the middle of the beam height reaching the end of the beam Figure 16. The overall crack pattern

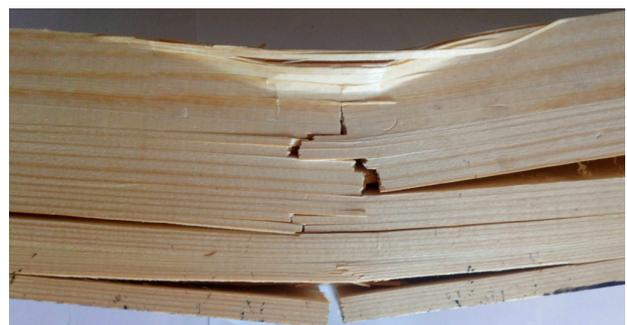
FIGURE 17. Back face of the beam #14.

on the back face is shown in Figure 17.
